Removing Trace Metals From Stormwater at an Industrial Hard Chrome Plating Facility

BY PAUL EGER, PEGGY JONES, DOUG GREEN, TOM POPLAWSKI, AND JOHN WAGNER

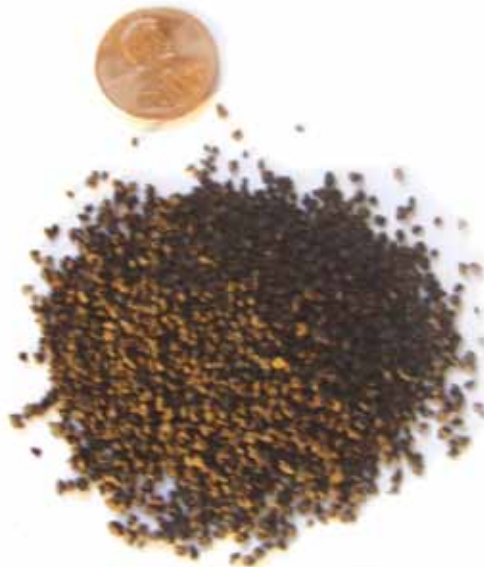
Figure 1. Peat granules

American Peat Technology (APT) has developed a granulation and low-temperature hardening process to convert loose natural reed sedge peat into an engineered sorption media called APTsorb (Figures 1 and 2). The granules maintain their structure when wet and can be sized to any specification, which makes them readily adaptable

to a variety of treatment systems. The standard media is 0.6 to 2 millimeters and has an estimated hydraulic conductivity around 1 centimeters per second. Metal removal capacities measured in laboratory equilibrium tests have ranged from 1 to 15% dry weight metal.
